TECHNICAL NOTE 4157

CORROSION RESISTANCE OF NICKEL ALLOYS IN
MOLTEN SODIUM HYDROXIDE

By H. B. Probst, C. E. May, and Howard T. McHenry

Lewis Flight Propulsion Laboratory
Cleveland, Ohio

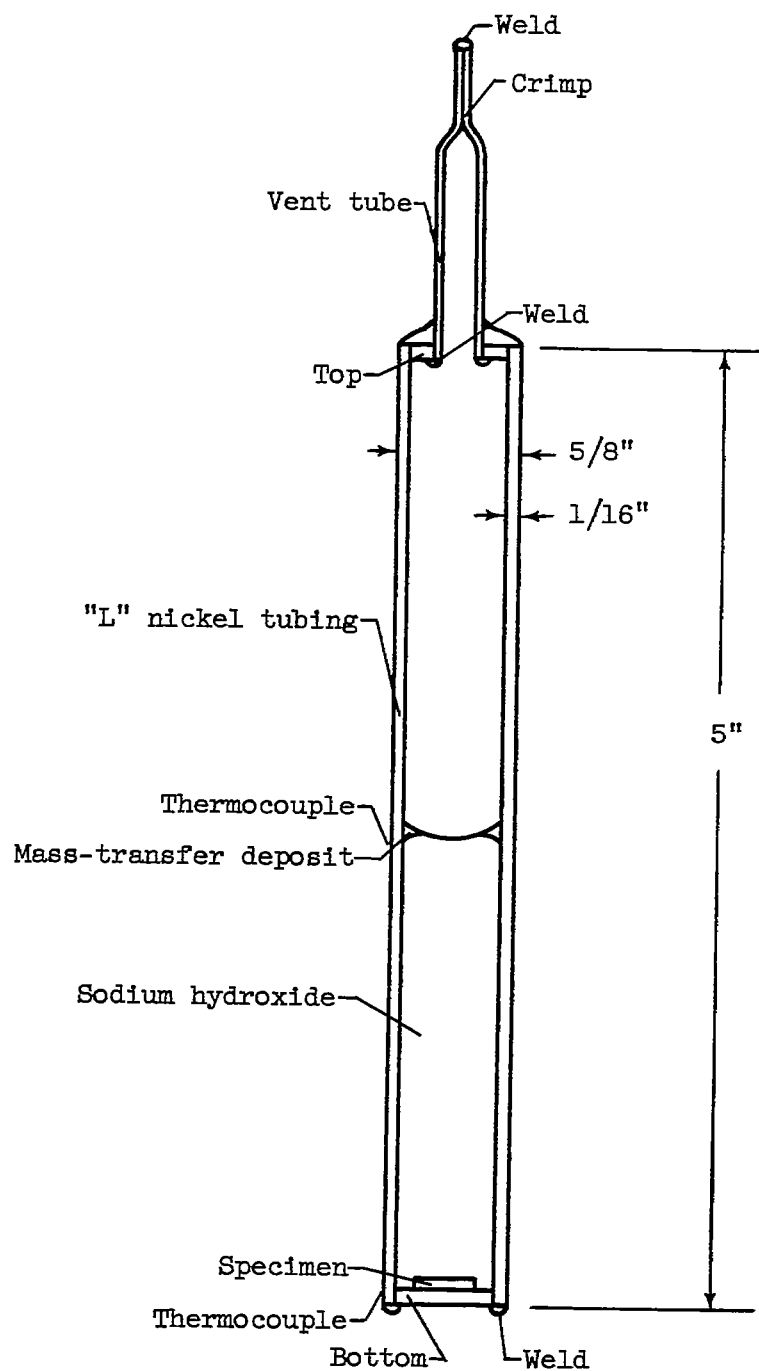
Figure 2. - Corrosion test capsule assembly.

The corrosion tests were run in "L" nickel capsules of the geometry shown in figure 2. A specimen was placed at the bottom of each capsule. The components of each capsule assembly, that is, tube, top, bottom, and vent tube, were cleaned in modified aqua regia (ref. 12) before assembly for 2 minutes.

After the bottom was welded in place, the weighed test specimen was placed in the capsule and sodium hydroxide (13.0 ± 0.1 g) was then added to the capsule in a helium dry box. The top and vent tube were then welded in place by means of a modified heliarc welding process. A welding atmosphere of helium plus 15 percent hydrogen was maintained while argon flowed through the assembly during welding.

Moisture and air were removed by evacuating to a pressure of 5 microns of mercury at 580° F (below the melting point of NaOH) and then evacuating to a pressure of 5 microns of mercury at 720° F (above the melting point of NaOH). The approximate times required for the two evacuations were 16 hours and 4 hours, respectively. Following the evacuation and cooling process, a cover gas of helium at a pressure of 2 pounds per square inch gage was admitted and the assembly sealed by crimping and welding the vent tube. Thermocouples were spotwelded to the capsules 1/8 inch from the bottom and also at the liquid level, $2\frac{1}{2}$ inches from the bottom.

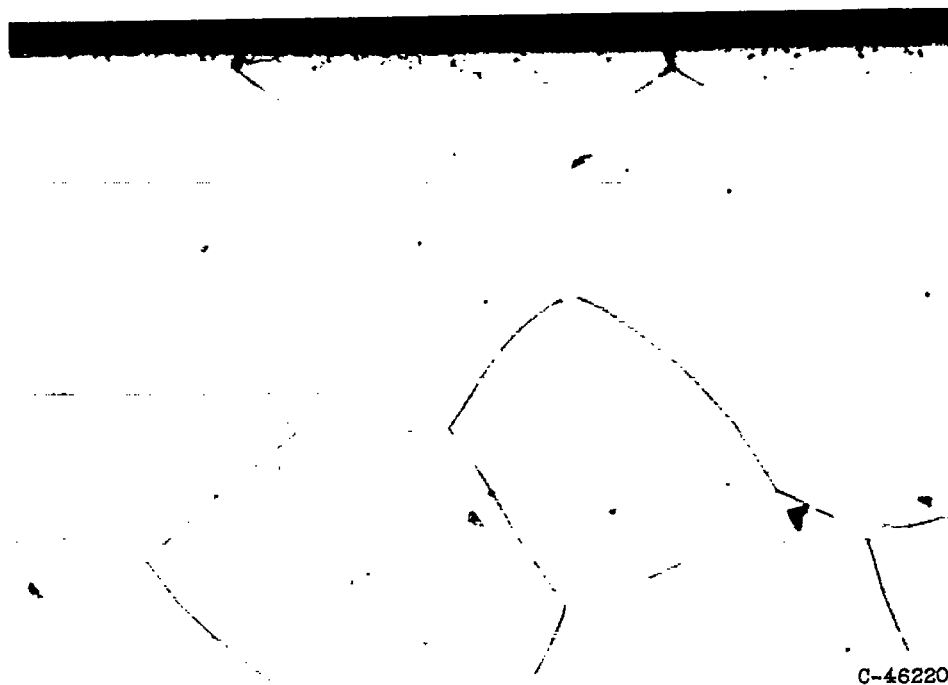
Figure 3. - Nickel plus 5 percent molybdenum after corrosion test at 1700° F. Etched; X250.

Nickel plus molybdenum. - No change was noted in the microstructure of the nickel plus 5 percent molybdenum composition after testing at 1500° F; however, slight intergranular attack resulted at 1700° F, as shown in figure 3. Leaching of molybdenum from the solid solution was slight at both temperatures, as measured by analysis of the sodium hydroxide.

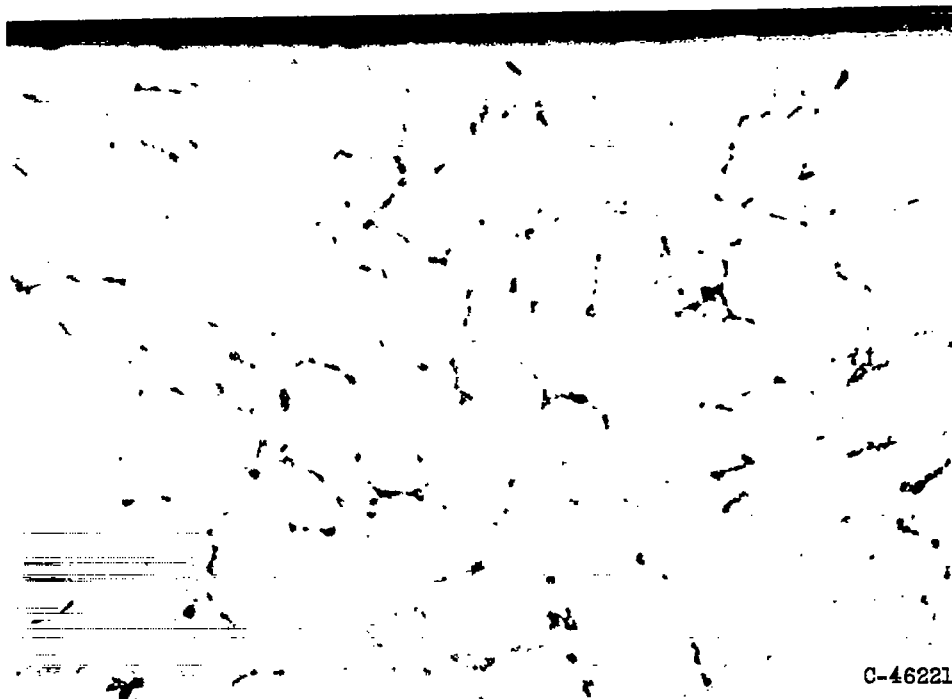
Figure 4. - Nickel plus 1 percent zirconium after corrosion test at 1700° F. Unetched; X250.

1700° F, shown in figure 4, is about twice as deep as at 1500° F. The intergranular attack at 1700° F is characterized by a foreign phase in the grain boundaries; no such phase was observed after the 1500° F test. Leaching at 1500° and 1700° F was not severe, as indicated by chemical analyses. However, X-ray data indicated that there was at least surface leaching at both temperatures.

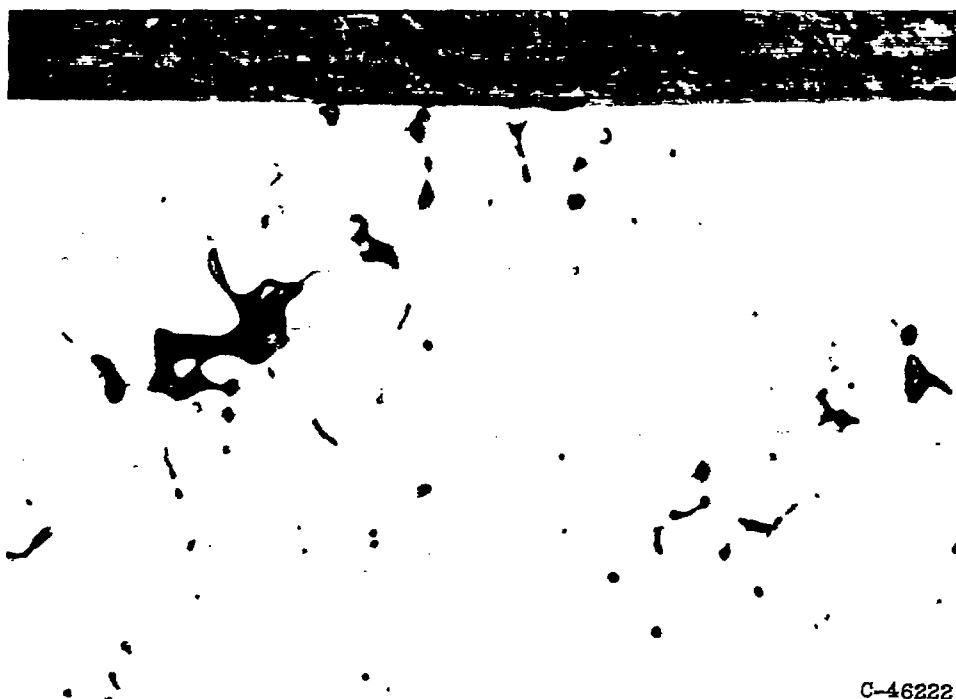
Figure 5. - Nickel plus 5 percent tin after corrosion test at 1700° F. Etched; X250.

Nickel plus tin. - No change in microstructure was noted for the nickel plus 5 percent tin alloy after testing at 1500° F. Some intergranular attack was observed after the 1700° F test. A foreign phase was present in the grain boundary regions as shown in figure 5. Since the leaching appeared to be slight at 1700° F, according to chemical analysis, it was assumed to be slight at 1500° F as well. However, chemical analysis was lacking for the lower temperature sample. X-ray diffraction data showed similar changes in the lattice parameter after the tests at both temperatures, indicating at least surface leaching.

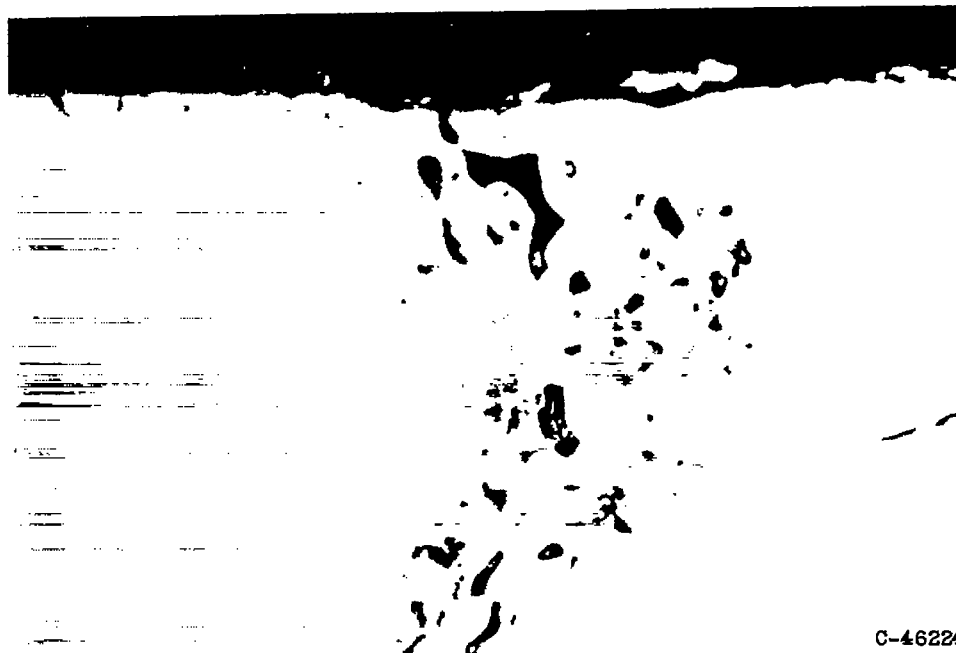
(c) Microstructure. Temperature, 1700° F. Unetched; X500.

Figure 6. - Concluded. Nickel plus 15 percent columbium after corrosion test.

Nickel plus columbium. - The nickel plus 15 percent columbium alloy showed an unusual reaction to sodium hydroxide. The swelling that occurred on the surface at 1500° F and the microstructure of this swelling are shown in figures 6(a) and (b), respectively. The surface of the swell is a single phase, while the body of the swell contains a foreign phase. The microstructure of this composition after the 1700° F test is shown in figure 6(c). Grain boundary attack is evident with a foreign phase present in the grain boundary regions. While it is not evident in the photomicrograph, a slight surface swelling was present after the test at 1700° F. Both X-ray and chemical analysis data indicated that considerable leaching of columbium had taken place at both test temperatures.

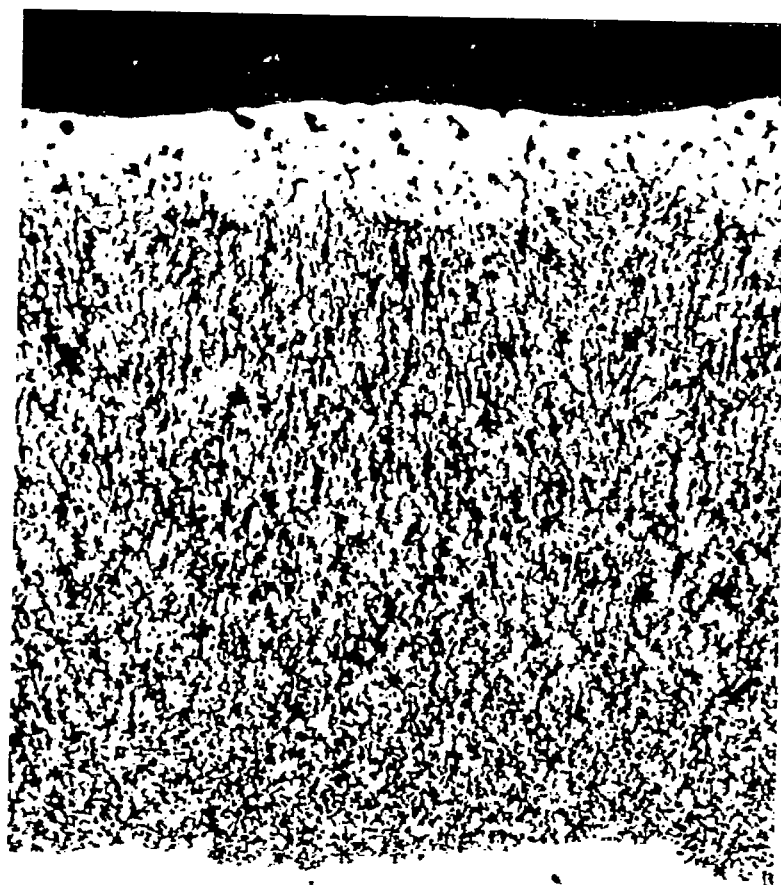
(a) Temperature, 1500° F. Unetched; X250.

Figure 7. - Nickel plus 15 percent manganese after corrosion test.

Nickel plus manganese. - Another material showing abundant formation of a foreign phase at 1500° F was nickel plus 15 percent manganese. In this case, however, the foreign phase was not localized and appeared to have formed with no volume change (fig. 7(a)). The surface of the sample was pure nickel as shown by X-ray diffraction data. This region may have been depleted of manganese rather than being plated as there is no evidence of any interface. Localized formation of the foreign phase with some surface swelling resulted after the 1700° F test, as shown in figure 7(b). Chemical analysis showed only minor leaching at both temperatures.

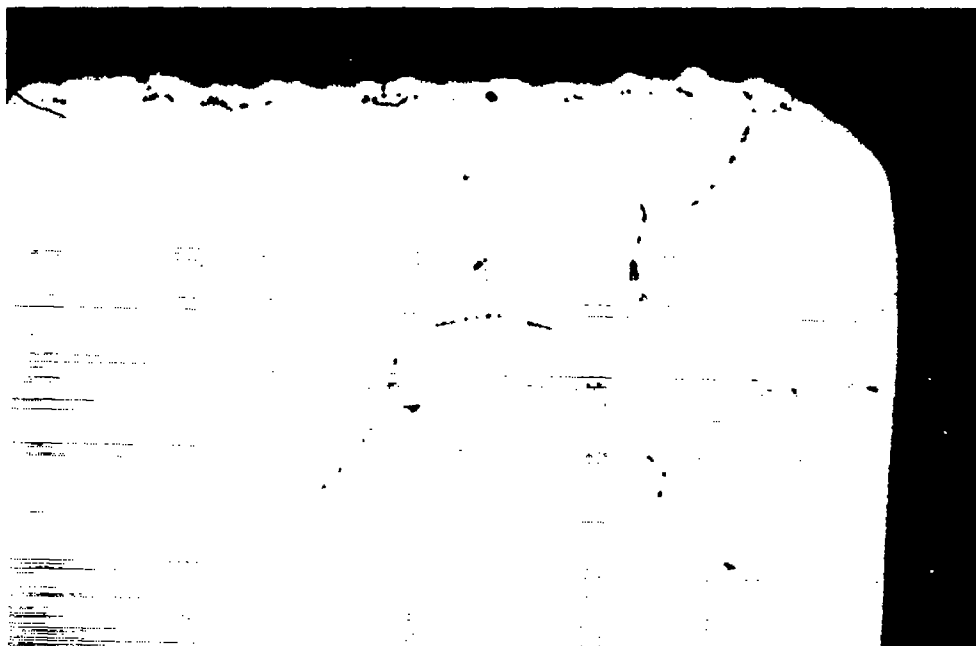
Figure 8. - Nickel plus 1 percent silicon after corrosion test at 1700° F. Etched; X100.

Nickel plus silicon. - There was no change in the appearance of the microstructure of the nickel plus 1 percent silicon alloy after testing at 1500° F, but slight intergranular attack resulted at 1700° F as shown in figure 8. This composition showed the greatest leaching effect of all the compositions studied. At both 1500° and 1700° F, virtually all the solute was leached by the sodium hydroxide. Thus, this alloy has no advantage over pure nickel, since the alloy is essentially changed to pure nickel when exposed to molten sodium hydroxide.

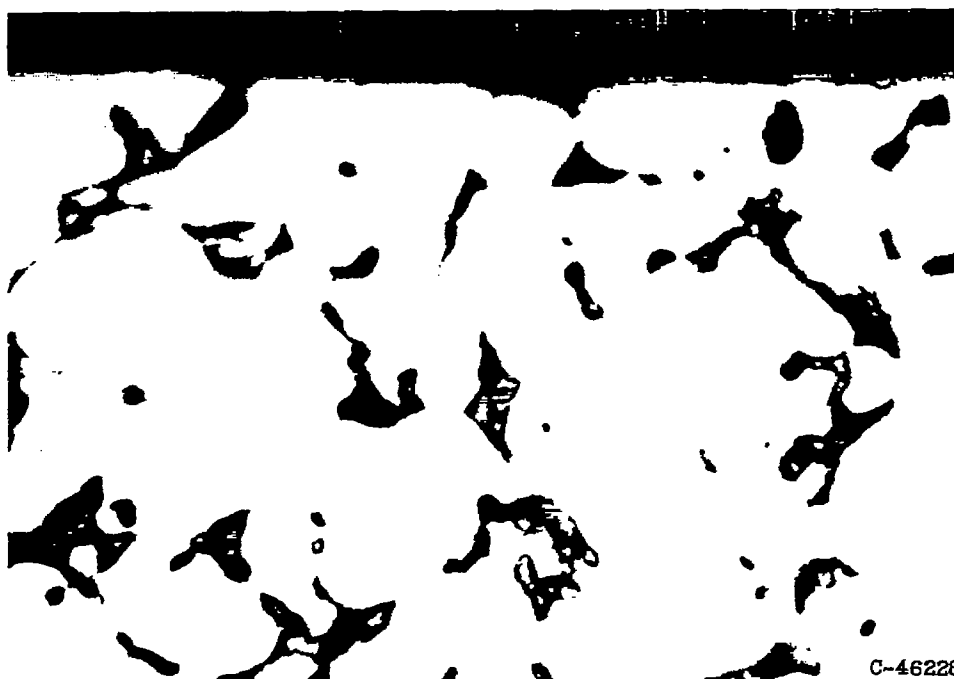
Figure 9. - Nickel plus 4.3 percent magnesium oxide after corrosion test at 1700° F. Etched; X500.

The group of materials with mechanically dispersed second phases possessed generally good corrosion resistance. There was no intergranular attack at either 1500° or 1700° F. Contrary to expectation, however, the attack of refractory particles was not confined to the particles exposed at the surface. Microscopic examination showed that particles below the surface had been removed, leaving voids. Figure 9 is a photomicrograph of the nickel plus magnesium oxide material after corrosion test at 1700° F. The nickel plus titanium carbide compositions showed a similar removal of titanium carbide particles. In addition to voids, the nickel plus 8.2 percent titanium carbide specimen tested at 1700° F contained a dark foreign phase near the surface similar to that noted in a number of the solid-solution alloys.

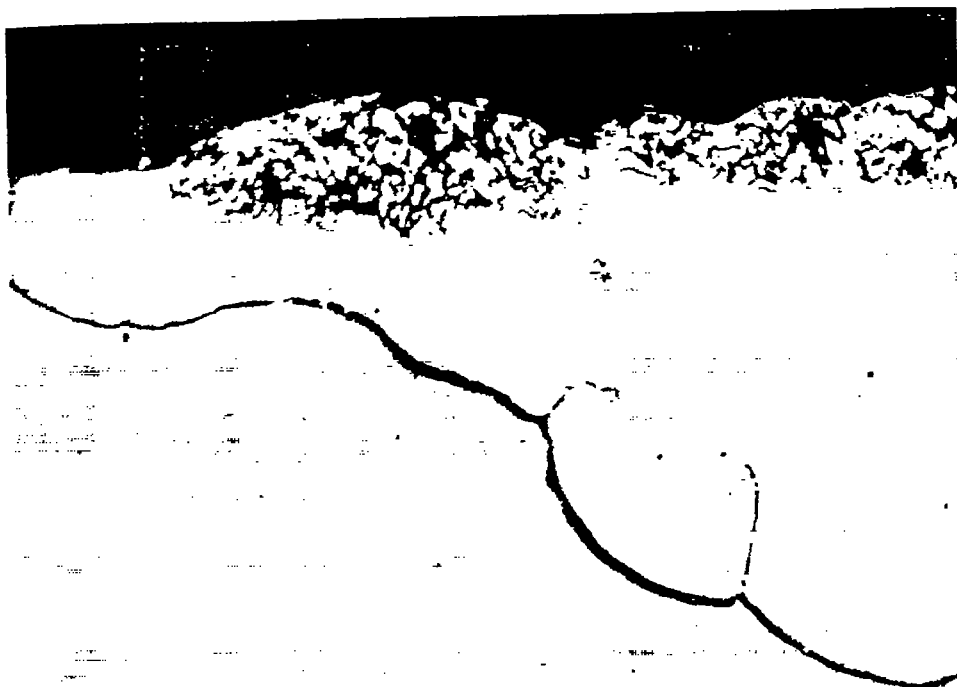
(b) Temperature, 1700° F. Unetched; X200.

The nickel plus 11 percent titanium alloy was severely attacked by molten sodium hydroxide both at 1500° and 1700° F. As shown in figure 10, attack was predominantly intergranular. The grain boundary regions were depleted of titanium and showed the presence of a foreign phase. In addition, specimens tested at both temperatures also showed localized surface swelling with a foreign phase in the swells.

During the test at 1500° F, a nickel plate formed on the specimen (fig. 10(a)); this presumably came from the nickel capsule. In figure 10(a), the surface swells containing the foreign phase appear to have been formed after the deposition of the nickel plate. An accompanying positive volume change is suggested by the ruptured plate. The internal boundary regions of the swells in figure 10(c) appear to be depleted of Ni₃Ti.

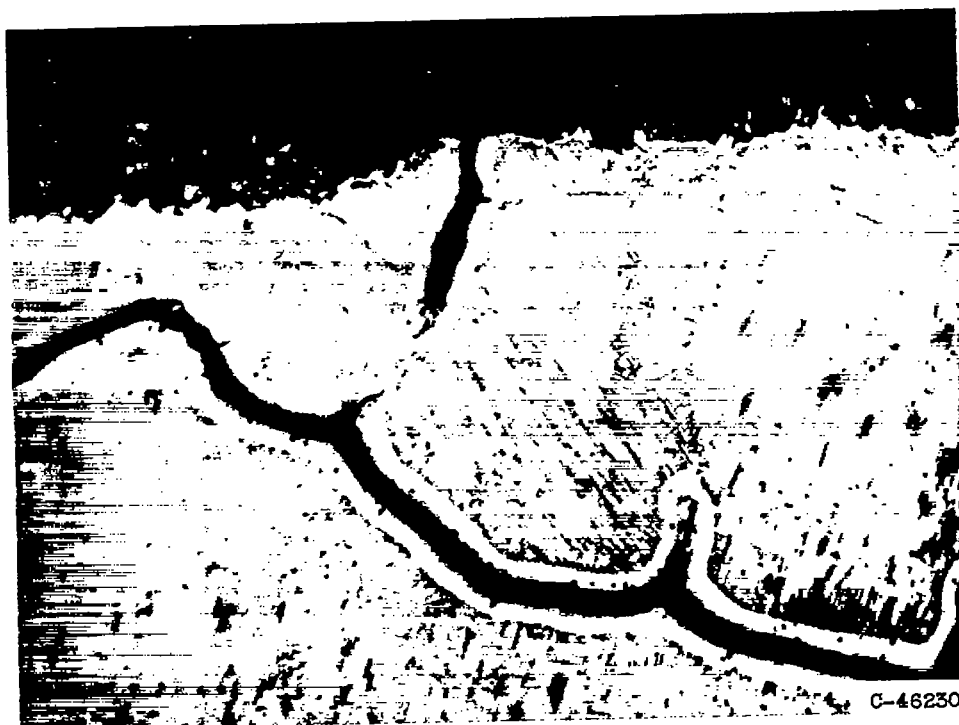
(c) Temperature, 1700° F. Etched; X250.

Figure 10. - Concluded. Nickel plus 11 percent titanium after corrosion test.
